Halton Borough Council
S19 Flood Investigation Report

A557 Watkinson Way
Flood at Cranshaw Hall Bridge
25th- 26th September 2017

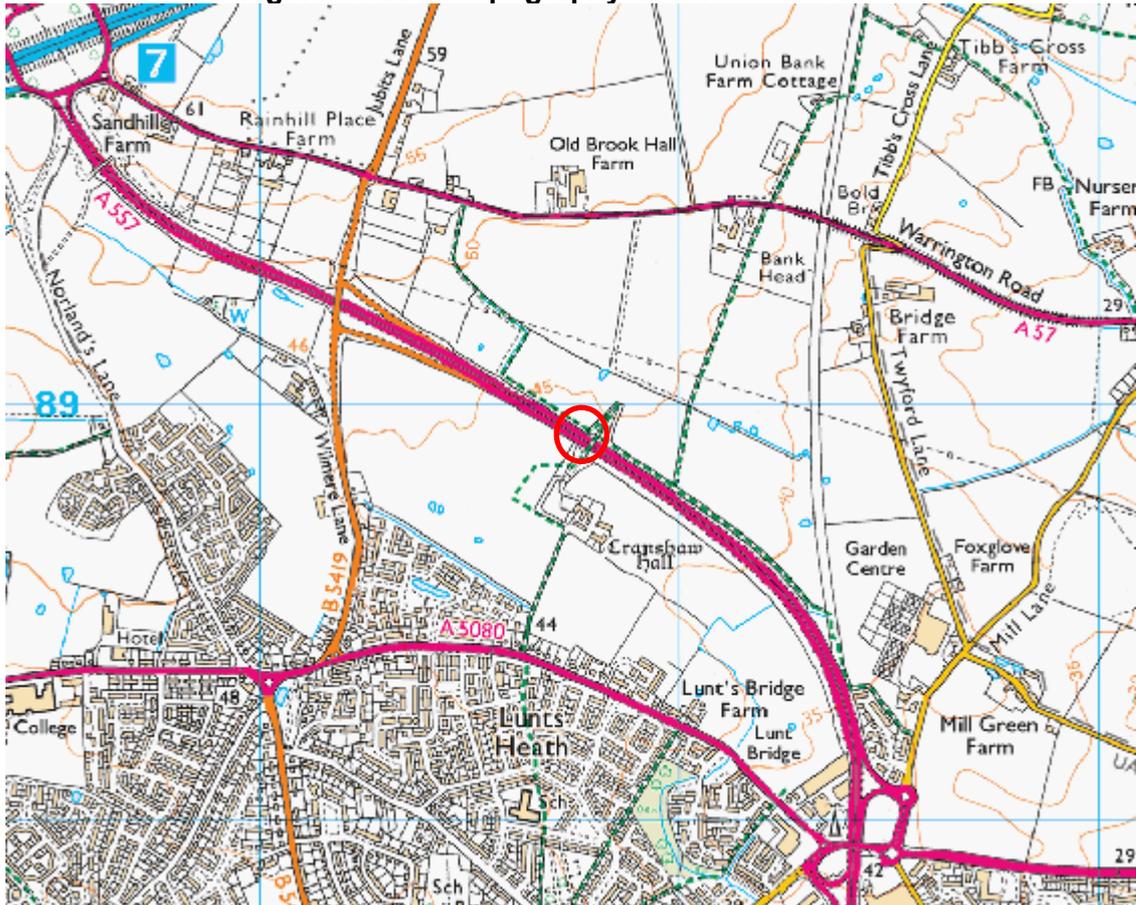
Figure 5.1 Area topography and flood location

Prior to the construction of the A557 the agricultural land sloped gently south-eastwards with surface water runoff/ land drainage contributing to the catchment of Bowers Brook. Upon construction of the A557 land drainage was intercepted by a series of ditches within the highway boundary on the north side of the highway, with regularly spaced culvert crossings allowing surface water to cross the highway to continue flow to Bowers Brook.

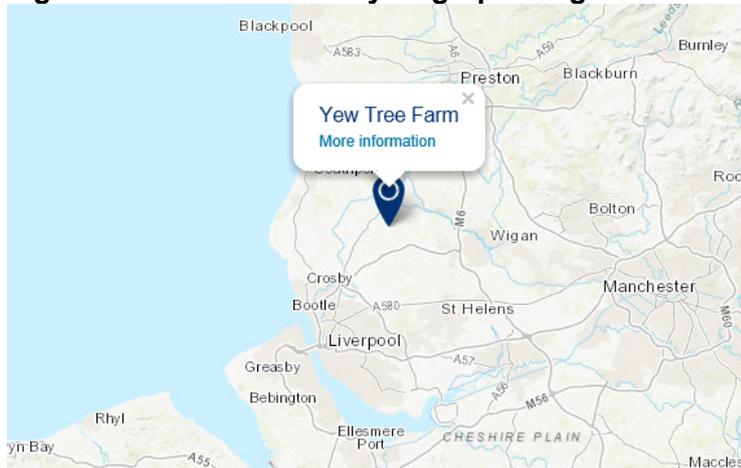
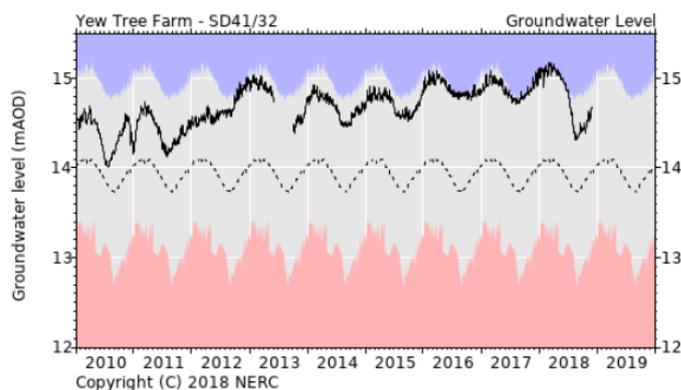
Figure 6.1 Location and Hydrograph for groundwater levels

No groundwater data is available for this immediate area, but the British Geological Survey site at Yew Tree Farm, Lancashire recorded notably high levels for September 2017.

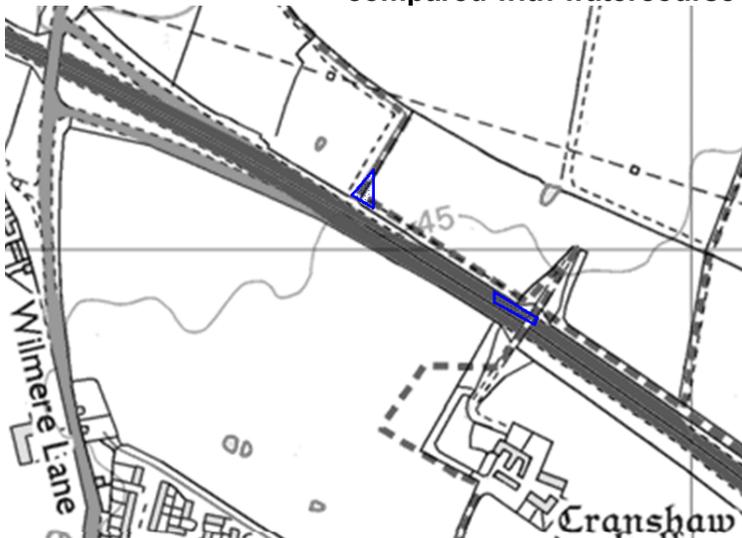
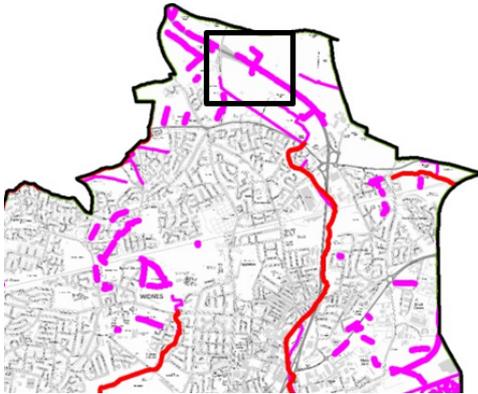
Figure 7.1: Overview of Flooding Locations for incident on 25th/26th September 2017 compared with watercourse locations

Watercourses shown pink, inset area showing flood extent

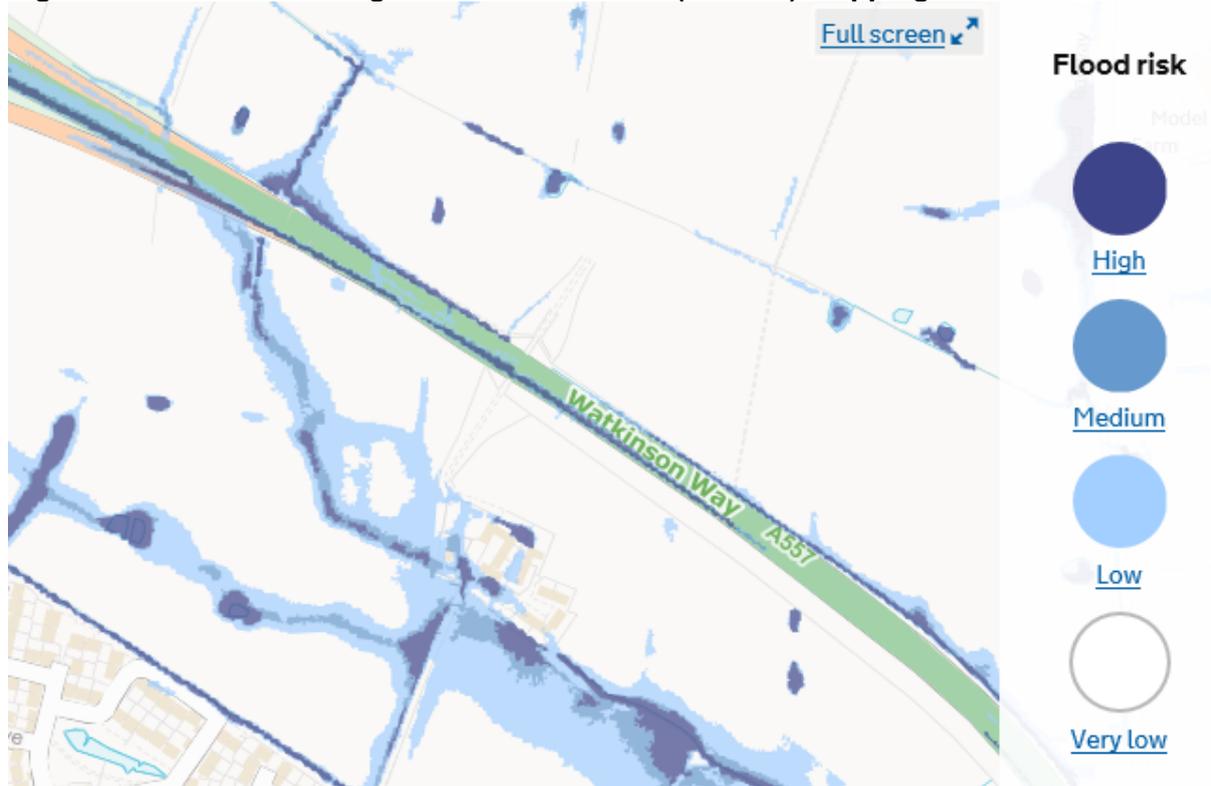
Figure 8.1 Risk of Flooding from Surface Water (RoFSW) mapping extract

However, it is important to note that this is national mapping product and does not represent reflect local detailed sewer drainage networks and is not designed to represent the risk of fluvial flooding from watercourses.
